SI B 24 50 99
Automatic Transmissions

January 2000
Service Engineering

Installing the Transmission Cooler Line Clip

E53 X5 SAV

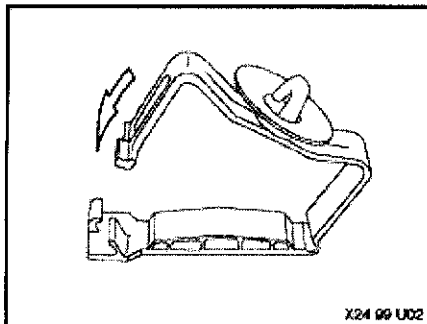
The clip securing the flexible transmission lines (from the transmission to the cooler) may not adequately hold the hoses in place.

2. Install the revised clip, P/N 17 22 1 719 407, onto the flexible transmission lines as described below:
