SI B24 51 02
Automatic Transmission

Transmission Oil Leak in Torque Converter Area

E53 X5 with M62 and A5S440Z transmission produced 9/99 – 5/00 up to transmission serial number 0345218

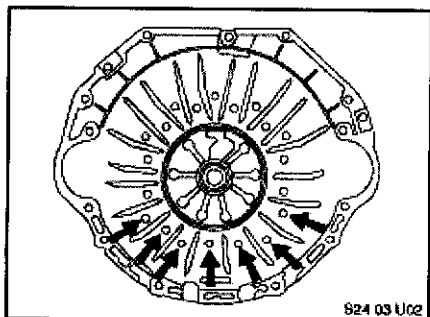
078955

Oil seepage through the threads of bell housing mounting bolts.

1. Remove transmission as outlined in repair instructions.
2. Remove torque converter.
3. Remove the seven bell housing mounting bolts indicated below.

4. Clean the threads of the seven mounting bolts.
5. Clean oil residue from the threads in the transmission housing.

6. Apply a moderate amount of Loctite 243 to the threads of the seven mounting bolts. Install bolts and torque to 46 Nm.
