This Service Information bulletin supersedes SI B24 01 08 **dated May 2010**.

ZF 6HP - Diagnosis for EGS FC 4F81

E60, E61 with N52K or N54 and ZF 6HP19TU (6HP21) or 6HP19X TU from SOP up to 02/08

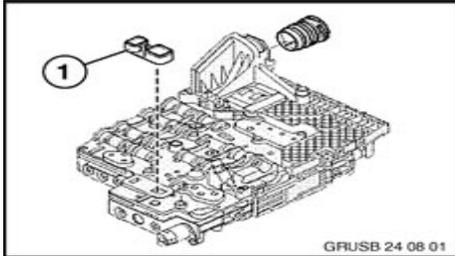
- a. Low transmission fluid level; or
- b. Internal transmission pressure leak caused by a defective adapter seal (rectangular) between the transmission housing and the Mechatronic.

4. If the Mechatronic adapter seal (rectangular) (1) is found to be defective (cracks, seal damage, etc.), replace it with the new part.
5. Reinstall the Mechatronic and an oil pan, using a new oil pan gasket, a new Mechatronic sealing sleeve (round), and a new drain plug. **The oil pan should NOT be replaced.**
6. Fill and adjust the transmission fluid, using the previously saved Shell M-1375.4 (P/N 83 22 0 142 516). For the filling procedure, refer to REP 00 11 500

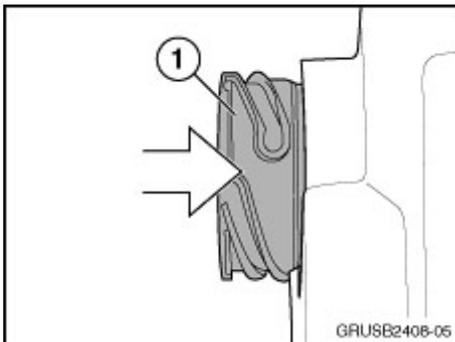
In case the sealing sleeve is not inserted correctly, an intermittent connection problem between the Mechatronic and the vehicle harness connector will occur, resulting in various EGS communication faults (e.g., FC 5079 "Serial wire message missing"; FC 507A "Serial line signal plausibility"); "Gearbox Emergency Program" light illumination; and the transmission entering failsafe mode.

Make sure to push the sealing sleeve firmly into the housing assembly before closing the white locking tab of the Mechatronic.

To ease the sleeve installation, use some lubrication (e.g., transmission fluid) on both sleeve's o-rings.

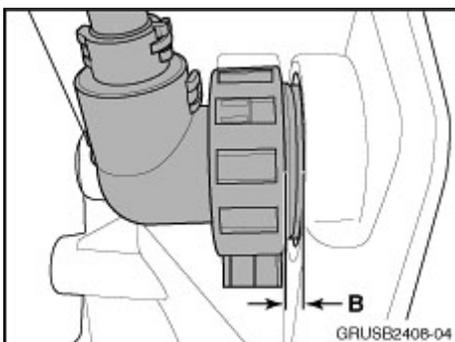
After installation, the correct distance between the transmission harness connector and the housing surface (B) should not exceed 3 mm.
