This Service Information bulletin supersedes SI B24 08 06 **dated March 2010**.

### ZF 6HP Transmissions - Mechatronic Sealing Sleeve Seepage

**NEW** E53, E60, E61, E63, E64, E65, E66, E85, E90, E91, E92, and E93 vehicles with ZF 6-speed 6HP19/21 or 6HP26/28 transmissions produced up to 04/08

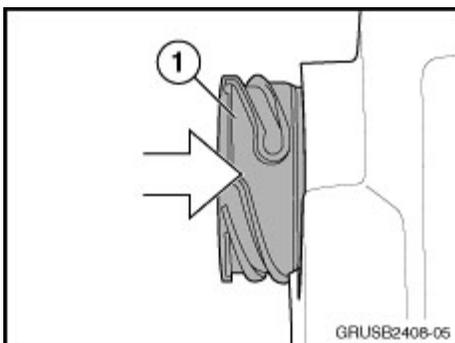
Transmission fluid seepage is visible in the area of the transmission oil pan. In most cases, only an oil "wetness" spot is spotted in the back of the transmission oil pan (the transmission fluid does not drop on the ground).

The Mechatronic sealing sleeve's O-ring tightness

**NEW** The "oil wetness" in the area of the sealing sleeve is not an indication of substantial leak, and does not justify this repair.

**NEW** 1. Only if a visible leakage trace indicates a substantial loss of transmission fluid (e.g., transmission fluid accumulation on the underbody panel), replace the Mechatronic sealing sleeve.

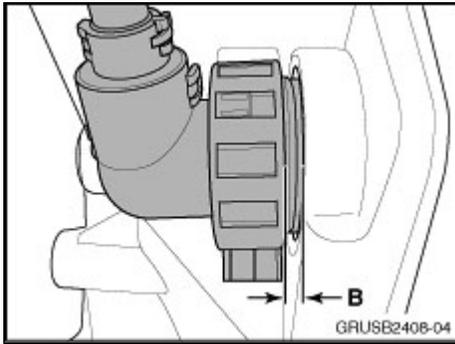
3. After installation, the correct distance between the

transmission harness connector and the housing surface (B) should not exceed 3 mm.

When installing the transmission harness connector, do not use excessive force - locking of the connector should not require an increased effort. This would be an indication of an incorrectly installed sealing sleeve!!!

Make sure to push the sealing sleeve firmly into the housing assembly before closing the white locking tab of the Mechatronic.

To ease the sleeve installation, use some lubrication (e.g., transmission fluid) on both sleeves' O-rings.

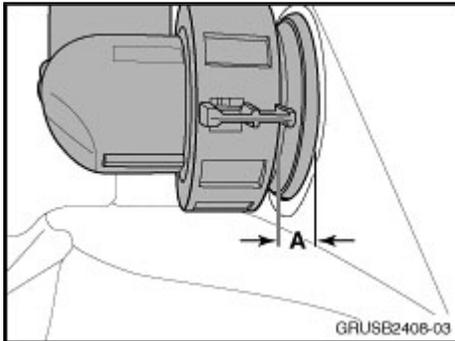
**NEW** 4. If the distance between the connector and the transmission housing (A) measures approximately 7 to 8 mm, the sealing sleeve was installed incorrectly. In such a case, an intermittent connection problem between Mechatronic and the vehicle harness connector will occur, resulting in various EGS communication faults (e.g., FC 5079 "Serial wire message missing"; FC 507A "Serial line signal plausibility"; "Gearbox Emergency Program" lamp illumination; and the transmission entering a failsafe mode).

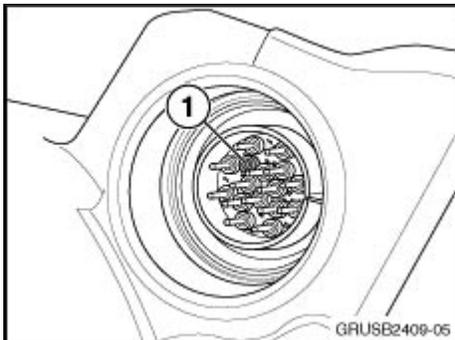
5. In some cases, the incorrectly installed sealing sleeve may permanently damage pins in the Mechatronic connector (X8500). In such a case, the Mechatronic module has to be replaced (**pin repair is not possible**).

The illustration shows an example of a broken and missing pin #4 in the X8500, caused by improper sleeve installation; this resulted in the customer's complaint about the inoperative Sport Mode of the transmission.
