This Service Information bulletin supersedes SI B24 08 06 **dated December 2008**.

### ZF 6HP19/6HP26 Transmissions - Mechatronic Sealing Sleeve Leaking

E53, E60, E61, E63, E64, E65, E66, **NEW** E85, E90, E91, E92, E93 with ZF 6-speed 6HP19 or 6HP26 transmission

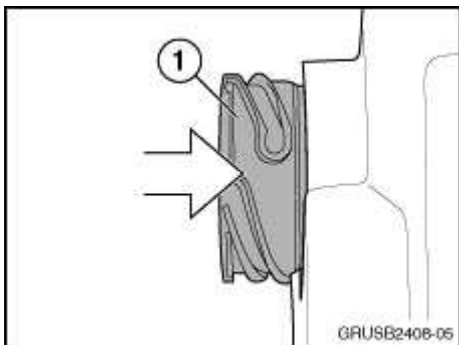
Transmission fluid leak coming from the area of the transmission oil pan

The Mechatronic sealing sleeve's o-ring leaks.

1. Drain and save the long-term fill transmission fluid (Shell M-1375.4).

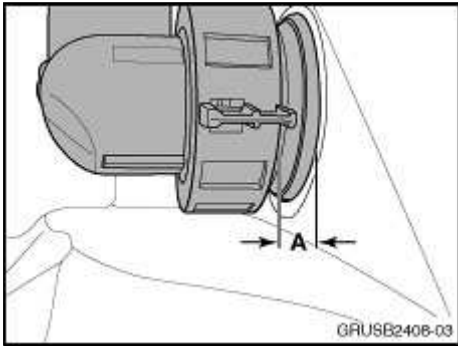
4. If the distance between the connector and the transmission housing (A) measures approximately 7 to 8 mm, the sealing sleeve was installed incorrectly. In such a case, an intermittent connection problem between Mechatronic and the vehicle harness connector will occur, resulting in various EGS communication faults (e.g., FC 5079 "Serial wire message missing"; FC 507A "Serial line signal plausibility"; "Gearbox Emergency Program" light illumination; and the transmission entering a failsafe mode).

3. After installation, the correct distance between the transmission harness connector and the housing surface (B) should not exceed 3 mm.
