This Service Information bulletin supersedes SI B24 08 06 **dated October 2008.**

ZF 6HP19/6HP26 Transmissions - Mechatronic Sealing Sleeve Leaking

E53, E60, E61, E63, E64, E65, E66 with ZF 6-speed 6HP19 or 6HP26 transmission

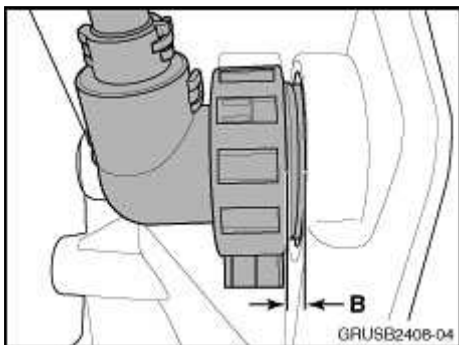
The Mechatronic sealing sleeve's o-ring leaks.

2. Replace the sealing sleeve (PN 24 34 7 519 357) and the transmission oil pan gasket. Follow Repair Instruction RA 24 34 020.

Make sure to push the sealing sleeve firmly into the housing assembly before closing the white locking tab of the Mechatronic.

To ease the sleeve installation, use some lubrication (e.g., transmission fluid) on both sleeves' o-rings.

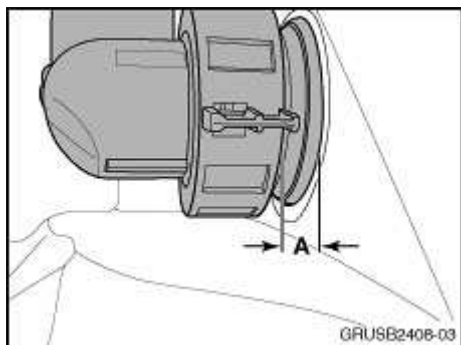
4. If the distance between the connector and the

transmission housing (A) measures approximately 7 to 8 mm, the sealing sleeve was installed incorrectly. In such a case, an intermittent connection problem between Mechatronic and the vehicle harness connector will occur, resulting in various EGS communication faults (e.g., FC 5079 "Serial wire message missing"; FC 507A "Serial line signal plausibility"; "Gearbox Emergency Program" light illumination; and the transmission entering a failsafe mode).

3. After installation, the correct distance between the transmission harness connector and the housing surface (B) should not exceed 3 mm.
